Manhole Inspection Summary

Manhole # S21M1_006MH

Insp Date: **5/1/08 1:38 PM**

Location Address: **2301 hollins ferry rd**

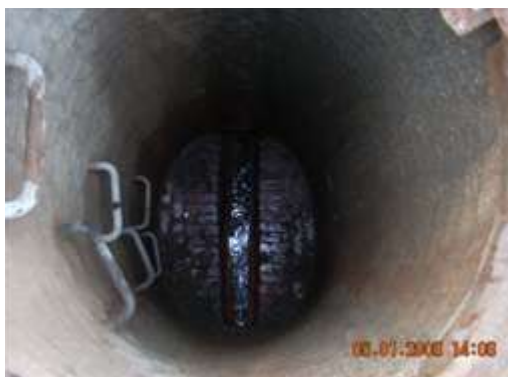
Misc.

Bench Debris

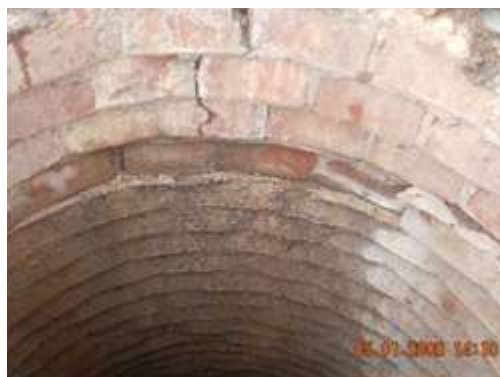
Defect 5

Condition: ☐ Sound ☒ **Cracked** ☐ Root Intrusion ☐ Loose Brick ☐ Deteriorated

Infiltration: ☐ None ☐ Joint ☐ Cracks ☒ **Mortar** ☐ Roots ☐ Wall

infiltration @ corbel wall, corbel cracked

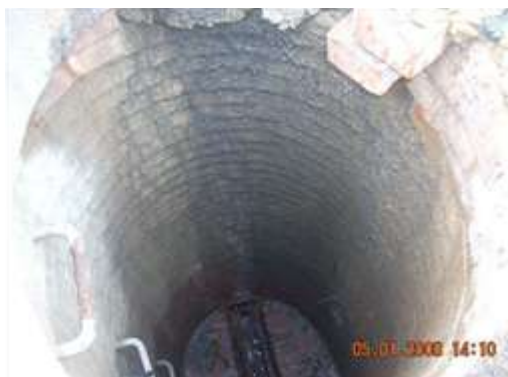
Defect 4

Infiltration: ☐ None ☒ **Joint** ☐ Cracks ☐ Mortar ☐ Roots ☐ Wall

infiltration @ chimney/frame joint

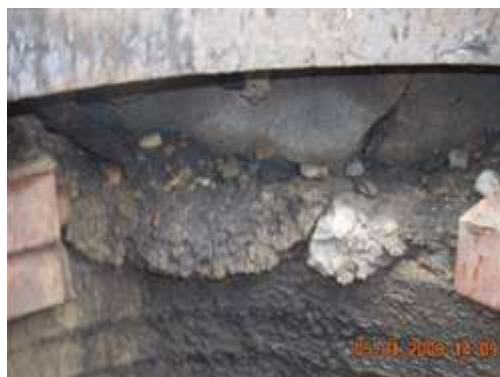
Defect 3

Condition: ☐ Sound ☐ Cracked ☐ Root Intrusion ☒ **Loose Brick** ☒ **Deteriorated**

deteriorated chimney; missing chimney bricks

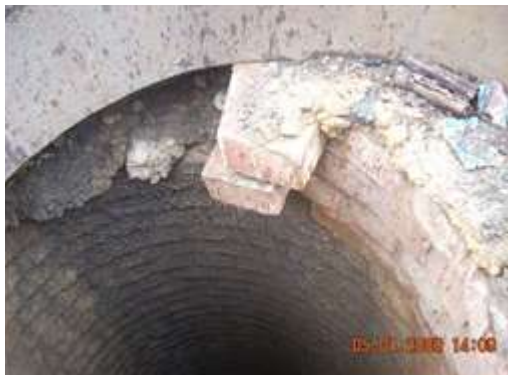
Defect 2

loose chimney brick

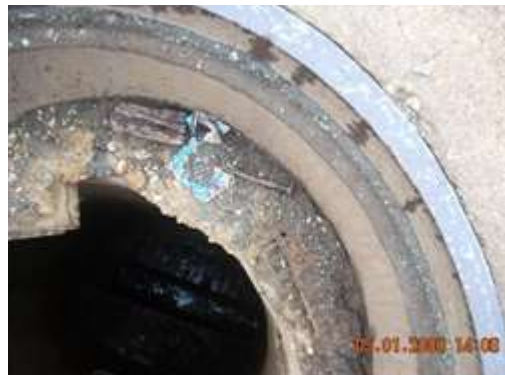
Defect 1

Offset: **4** (in.)

frame offset
